Manhole Inspection Summary

Manhole # S39U1_018MH

Insp Date: **2/19/08 10:08 AM**

Location Address: **200 Maude Ave** Cross Street: **Chesapeake Ave.**

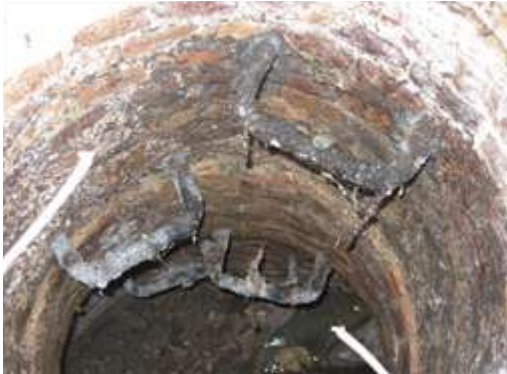
Steps Count: **5** Missing: **0** ☐ Corroded

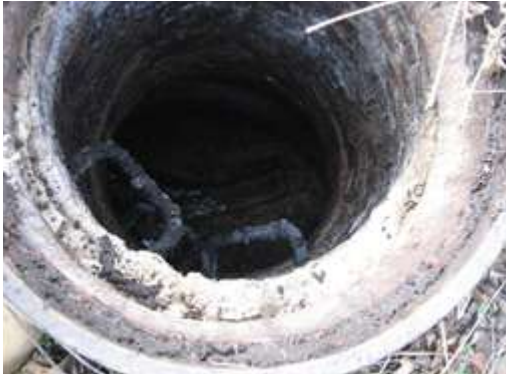
Defect 2

Frame Offset: **2.5** (in.) Condition: ☒ Sound ☐ Cracked ☐ Leaks

Frame offset

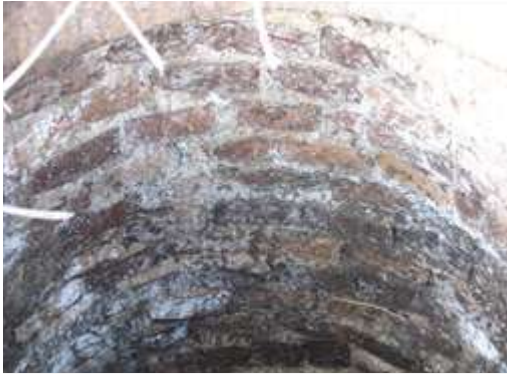
Defect 1

Chimney / Frame Adjustment ☒ Exists Material: **Brick** ☐ Parged Height: **30** (in.)
Condition: ☒ Sound ☐ Cracked ☐ Root Intrusion ☐ Loose Brick ☐ Deteriorated
Infiltration: ☐ None ☐ Joint ☐ Cracks ☐ Mortar ☐ Roots ☒ **Wall**

Corbel Material: **Brick** ☐ Parged Type: **Concentric/Eccentric**
Condition: ☒ Sound ☐ Cracked ☐ Root Intrusion ☐ Loose Brick ☐ Deteriorated
Infiltration: ☐ None ☐ Joint ☐ Cracks ☐ Mortar ☐ Roots ☒ **Wall**

Barrel Material: **Brick** ☐ Parged
Shape: **Circular** Diameter: **42** (in.) Length: (in.)
Condition: ☒ Sound ☐ Cracked ☐ Root Intrusion ☐ Loose Brick ☐ Deteriorated
Infiltration: ☐ None ☐ Joint ☐ Cracks ☐ Mortar ☐ Roots ☒ **Wall**

Wall

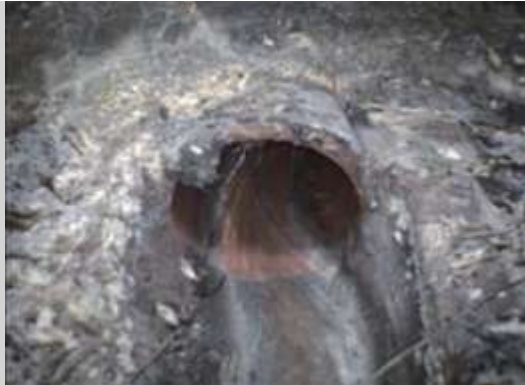
12 O'Clock Outflow

8 in. Circular Gravity Sewer
Pipe Out @ 12 O'Clock

Pipe Height: **8.4** (in.) Rod and Bar (Angled)
Pipe Material: **Clay** ☐ Pipe Lined
Invert Depth: **10.09** (ft.) Flow Characteristics: **Fast**
Deposits: ☒ None ☐ Mud ☐ Sludge ☐ Debris ☐ Grease
Silt Depth: (in.) Deposits Extent:
Infiltration: **None** Pipe Seal Cond: **Sound**

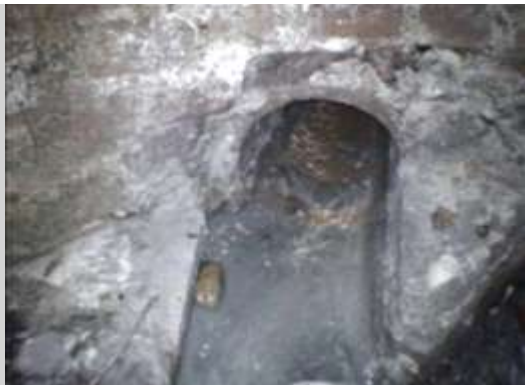
5 O'Clock Inflow

8 in. Circular Gravity Sewer
Pipe In @ 5 O'Clock

Pipe Height: **8.4** (in.) Rod and Bar (Angled)
Pipe Material: **Clay** ☐ Pipe Lined
Invert Depth: **9.65** (ft.) Flow Characteristics: **Fast**
Deposits: ☒ None ☐ Mud ☐ Sludge ☐ Debris ☐ Grease
Silt Depth: (in.) Deposits Extent:
Infiltration: **None** Pipe Seal Cond: **Sound**

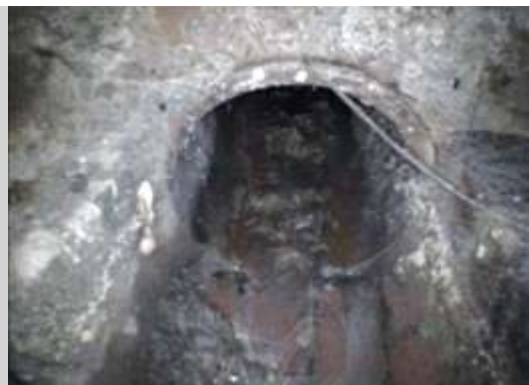
7 O'Clock Inflow

Pipe In @ 7 O'Clock

Invert Depth: **9.63** (ft.) Flow Characteristics: **Fast**

Infiltration: **None** Pipe Seal Cond: **Sound**
